Engineering Failure Analysis 10 (2003) 443–451

Failures of bolts in helicopter main rotor drive plate assembly due to improper application of lubricant

N. Eliaz^{a,b,*}, G. Gheorghiu^c, H. Sheinkopf^c, O. Levi^c,
G. Shemesh^c, A. Ben-Mordechai^c, H. Artzi^c

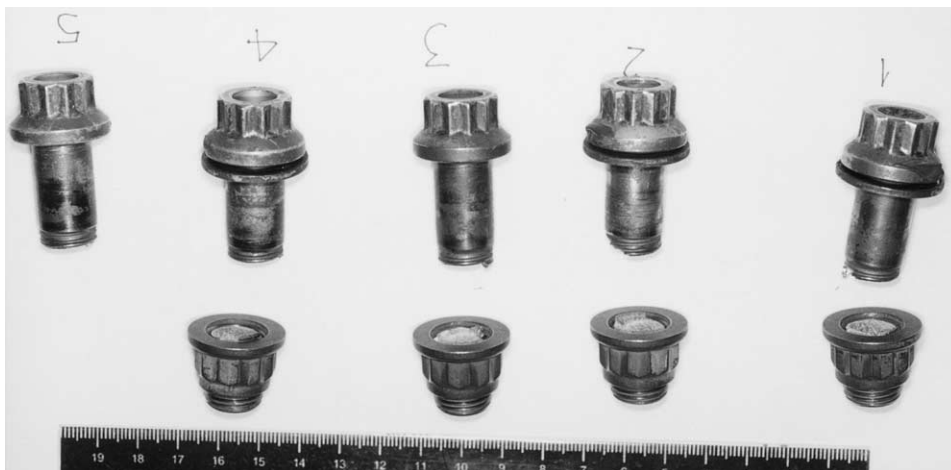
Visual inspection, macroscopic and microscopic examination of the fracture surfaces were carried out in the lab. Visual inspection revealed that all bolts fractured transversely, within the threads zone (Fig. 2). Residues of the antiseize material were found along the whole length of the bolts, not just along the threads zone. Inspection of the nuts did not reveal any special findings. Macroscopic examination of the fracture surface revealed a matt-gray granular pattern and flow lines propagating from the periphery of the bolt (Fig. 3). Microscopic examination of the fracture surfaces revealed equiaxed tear dimples, characteristic of ductile overload fracture mechanism (Fig. 4). Metallographic cross-sections, which were prepared perpendicular to the fracture surfaces and examined under the optical microscope, did not reveal any special findings such as unusual or gross metallurgical imperfections.

Fig. 2. Visual inspection of the failed bolts, showing transverse fracture within the threads zone.

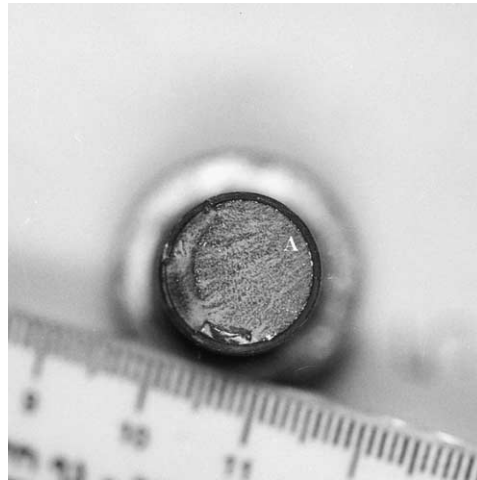
Fig. 3. A stereomicroscope macroscopic view of a typical fracture surface.

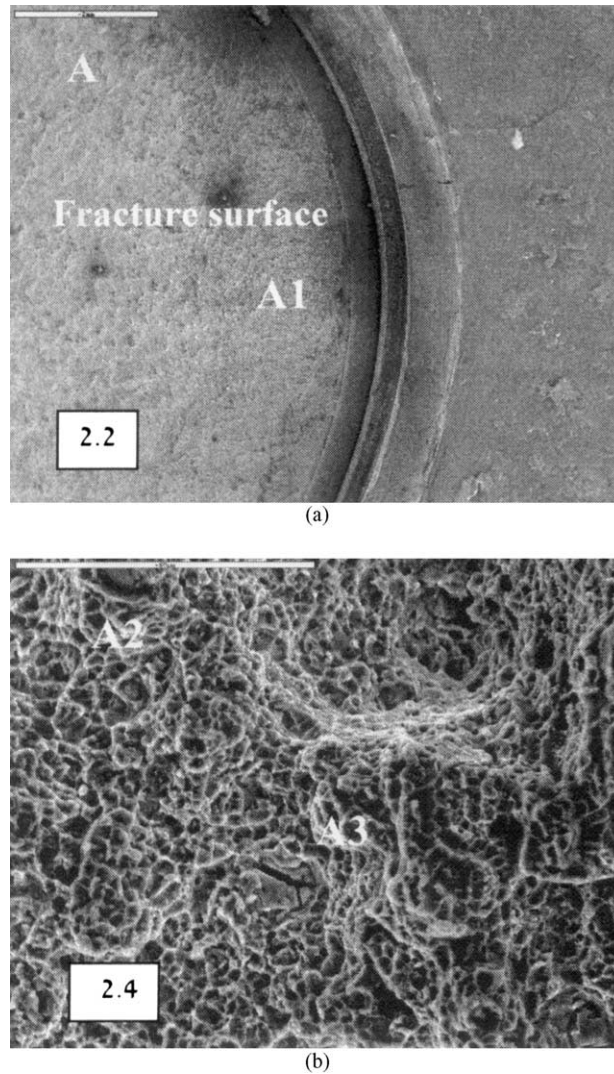
Fig. 4. SEM secondary electron images of a typical fracture surface: (a) high magnification of region A from Fig. 3; (b) region A1 from (a), showing tear dimples characteristic of overload fracture.

In conclusion, the bolts in the helicopter's main rotor drive plate assembly failed in overload mechanism. The cause of failure was improper application of the antiseize material on the whole length of the bolt, which resulted in the development of axial tension forces approximately 1.7 higher than normal. Following

this investigation, the maintenance team was instructed to always apply the antiseize material on the threads zone only, without necessity of surface precleaning with MEK. Although no limitation was found with respect to reuse of bolts (see note b of Table 1), it was recommended to clarify this issue with the manufacturer.
