# PREVENTATIVE MAINTENANCE AND FAILURE ANALYSIS OF AIRCRAFT COMPONENTS

Noam Eliaz<sup>1</sup> and Ronald M. Latanision<sup>2</sup>

## ABSTRACT

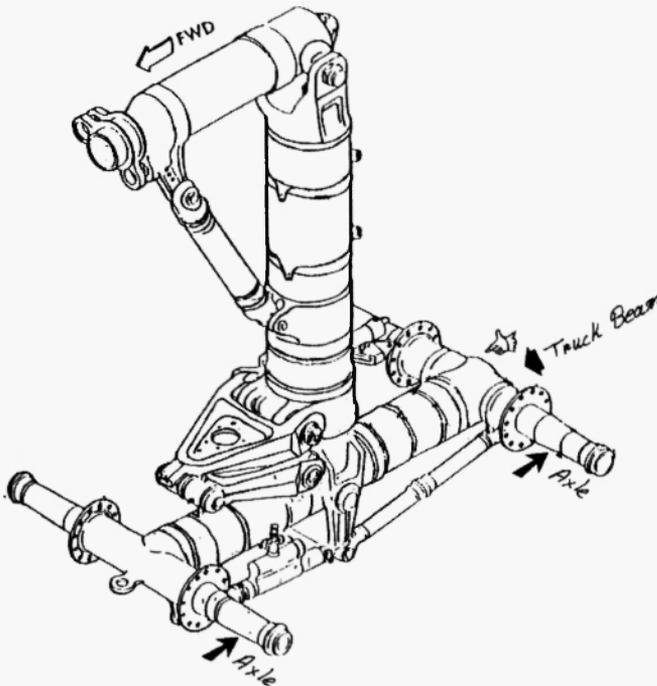
**Fig. 3:** Illustration of the main landing gear assembly on the subject aircraft. A finger marks the region of failure /17/.

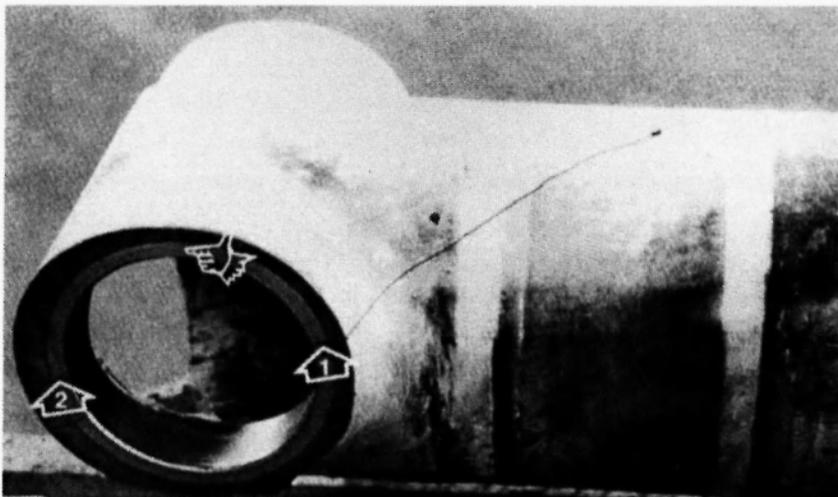
**Fig. 4:** Macroscopic view of the rear side of the R/H truck beam, revealing two crack origins (marked with arrows), one on each side of the bore /17/.

Visual examination of the R/H truck beam revealed no mechanical damage either in vicinity to the failure region or on the chromium plating. Macroscopic examination of the fracture surfaces revealed ratchet marks propagating from two origins beneath the chromium plating at two opposite locations on the outer wall of the axle (bore). The crack propagation path is shown schematically in Fig. 5. Around the origins, dark brown beachmark patterns were observed (Fig. 6).

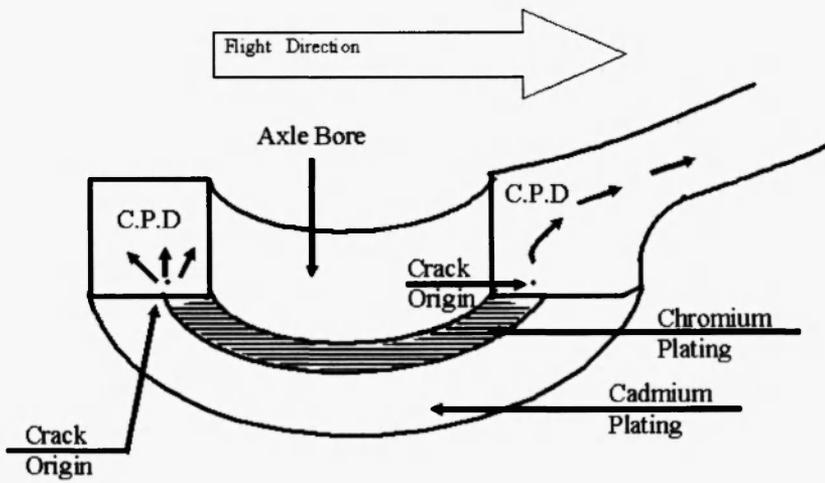
**Fig. 5:** Scheme of fracture. The chromium-plated zone, crack origins and fracture course are all marked /17/.

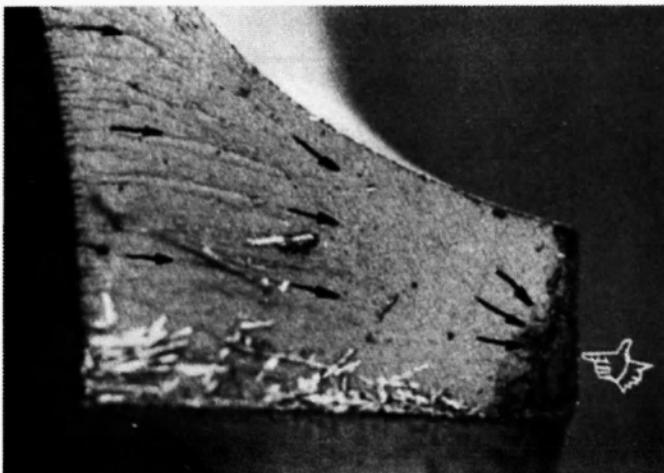
**Fig. 6:** Stereomicroscope image of the fracture surface around origin 1 from Fig. 4. A dark thumb-nail-shaped beachmarks region near the wall is marked with finger /17/.

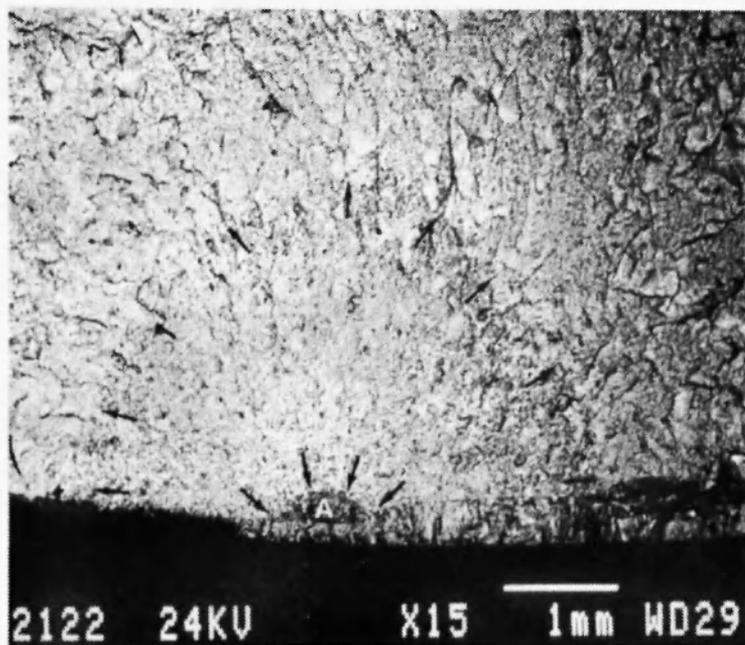
**Fig. 7:** SEM photomicrograph (back-scattered electrons image) showing origin 2 from Fig. 4 and its surroundings. Two thumb-nail-shaped beachmarks zones are marked by arrows. The origin is located within the runout plateau where the chromium layer is thin /17/.

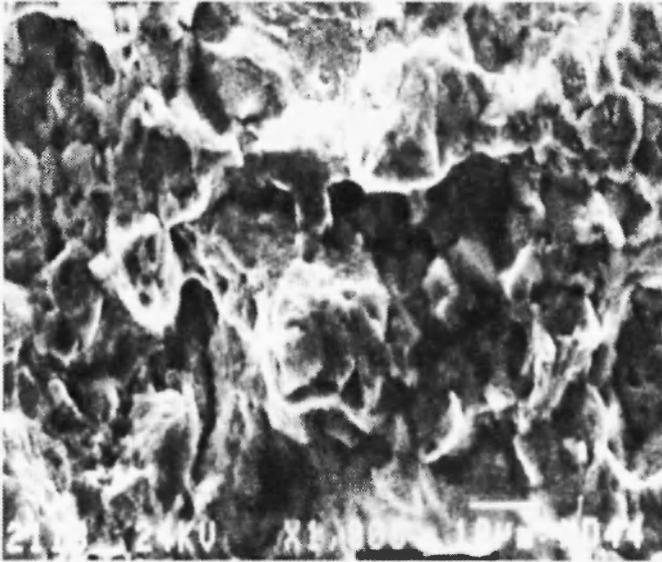
Higher magnification revealed that the inner beachmarks zone was consisted of chemical etching features characteristic of corrosion (Fig. 8). The outer beachmarks zone exhibited a coarse, grainy topography of intergranular separation (Fig. 9). The last portion of the fracture surface (not shown in Fig. 7) was characterized by rupture dimples and quasi-cleavage surfaces characteristic of overload failure.

**Fig. 8:** SEM photomicrograph demonstrating corrosion features within the inner beachmarks zone around origin 1 from Fig. 4 /17/.

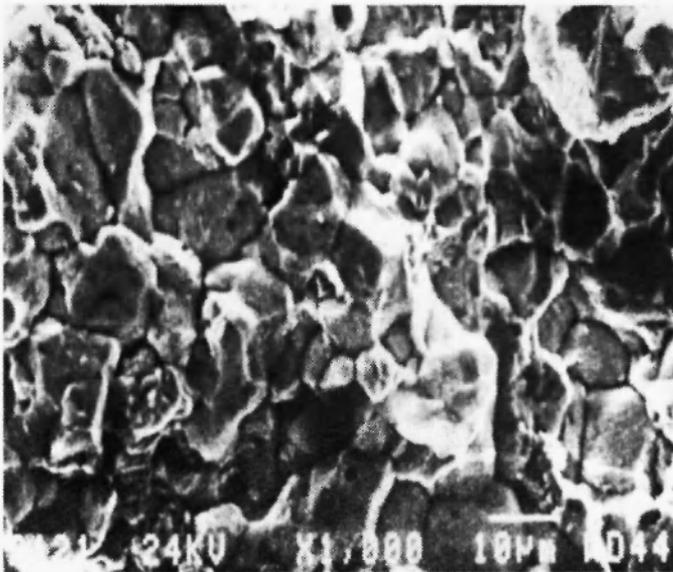
**Fig. 9:** SEM photomicrograph showing an intergranular fracture morphology within the outer beachmarks zone around origin 1 from Fig. 4. This morphology is typical, among other, to SCC /17/.

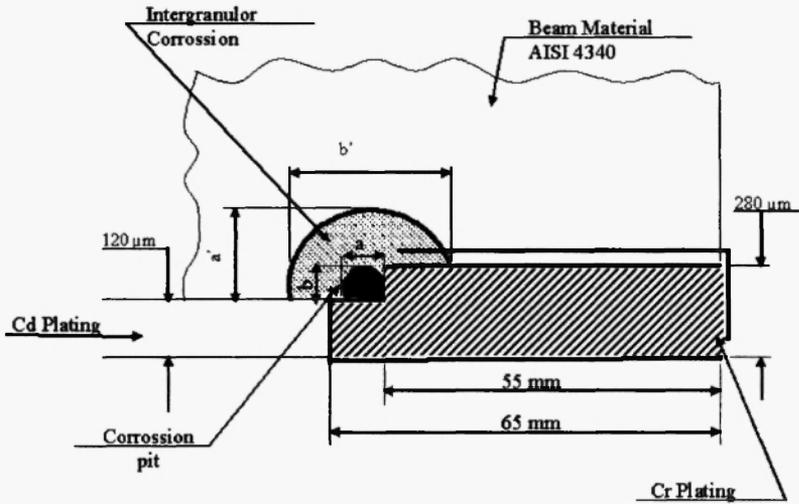
Thus, it was argued that both cracks initiated from corrosion pits under the chromium plating and propagated in a stable intergranular manner, namely SCC (see Fig. 10). Metallographic cross-section perpendicular to the crack surface through an origin further supported this argument, revealing many pits at the interface between the substrate and the chromium layer, through which cracks propagated within the chromium layer. In some cases, the crack that initiated around the pit penetrated into the substrate as well (see

**Fig. 10:** Scheme of the fracture surface. The area coated with chromium, the corrosion-related pit, and the intergranular corrosion region are shown not in scale /17/.

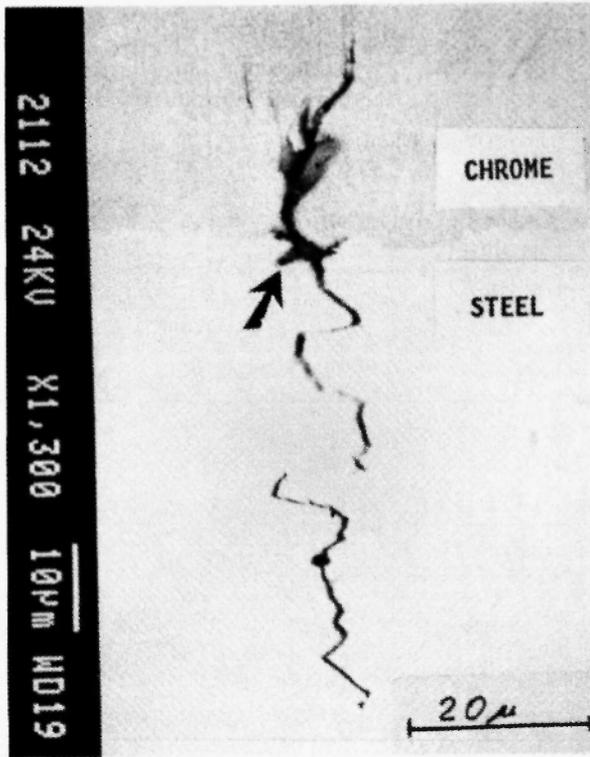
Fig. 11). Chemical analysis (by means of EDS) at the pit area showed residues of chlorine, which may often be related to corrosion processes. Similar observations were made for the L/H truck beam, in which the crack extended from the outer bearing surface of the axle bore approximately 10.2 cm to the aft end of the longitudinal bore.

**Fig. 11:** Microscopic view of an area close to one of the crack origins. The metallographic cross-section was prepared perpendicular to the fracture surface. A secondary crack propagating through the chromium layer into the substrate, in parallel to the fracture surface, is evident. A corrosion pit is evident at the interface between the substrate and the coating /17/.

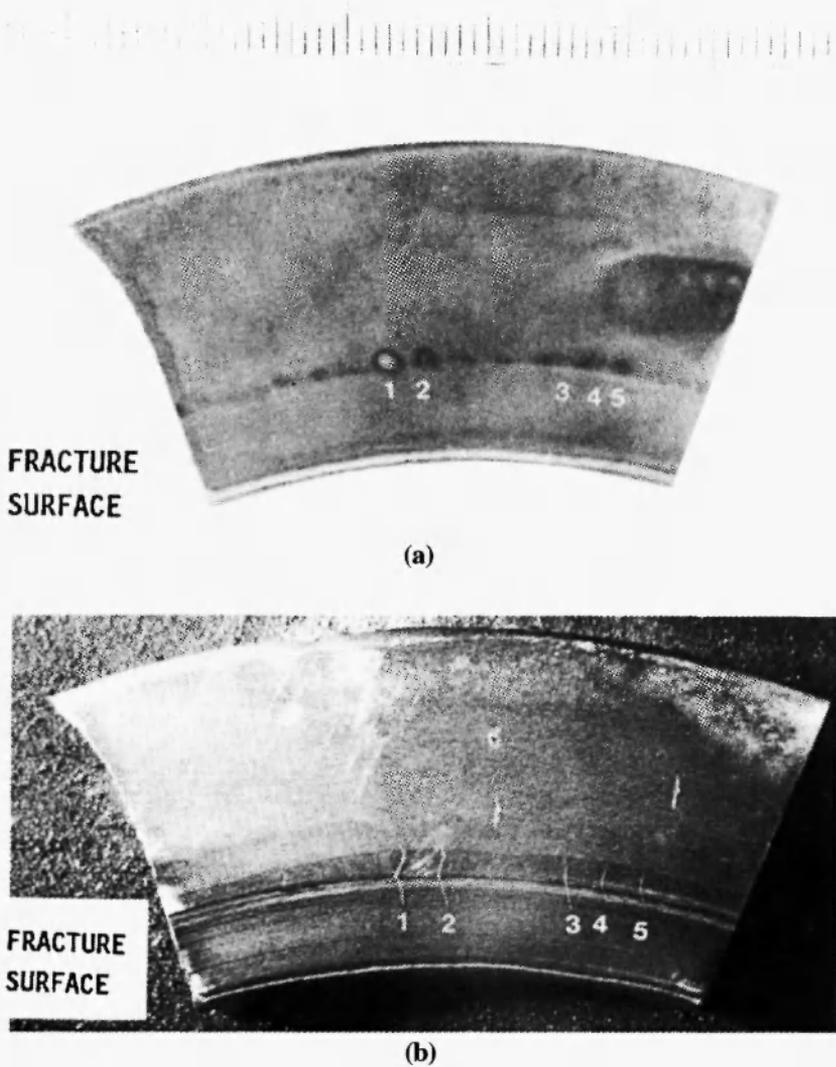
In order to better understand the nature of underfilm cracking, the coating was removed around the fracture zone in the R/H truck beam, and Nital etch was carried out in accordance with MIL-STD-867 following fine sand blasting. This revealed already macroscopic areas of overtempered and untempered martensite, indicative of heat damage incurred during abusive grinding (Fig. 12a). These heat-affected areas were located in the chromium plating runout plateau adjacent to the counterbore transition radius, at the edge of the milling (step) zone, and exhibited numerous thermally-induced secondary cracks (Fig. 12b). A similar condition was also observed in the same area on the bearing surface of a piece sectioned from the L/H truck beam specimen. Longitudinal heating marks could be related to the path of the grinding stone on top of the chromium layer. The microstructure of the material in the heat-affected areas and in the area adjacent to the origin of each fracture surface was consistent with overtempered martensite. The

**Fig. 12:** View of the bearing surface of the R/H truck beam specimen. (a) Areas of overtempered and untempered martensite after Nital etch. Magnification ~1.9X. (b) Thermally-induced cracks present in the heat-affected areas revealed by magnetic particle inspection. Magnification ~1.4X /17/.

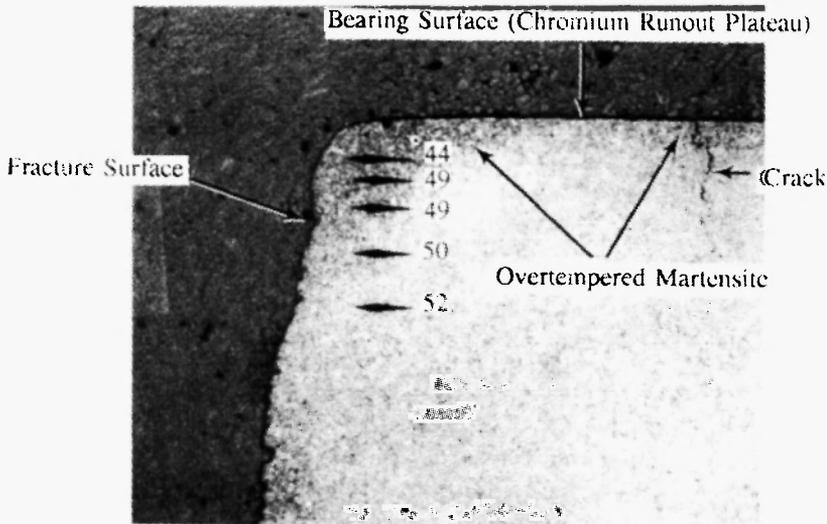
hardness of the material in these areas was lower than that of the surrounding tempered martensitic structure (Fig. 13).

**Fig. 13:** Photomicrograph showing the overtempered martensitic microstructure (dark area) adjacent to the origin of the fracture surface from the L/H truck beam specimen. Microhardness Knoop measurements (values converted to HRC) were taken in this area and the surrounding normal tempered martensitic structure and are shown to the right of the indentations. Note the crack (arrow) emanating from the bearing surface in a similar overtempered martensitic area. Magnification ~100X /17/.

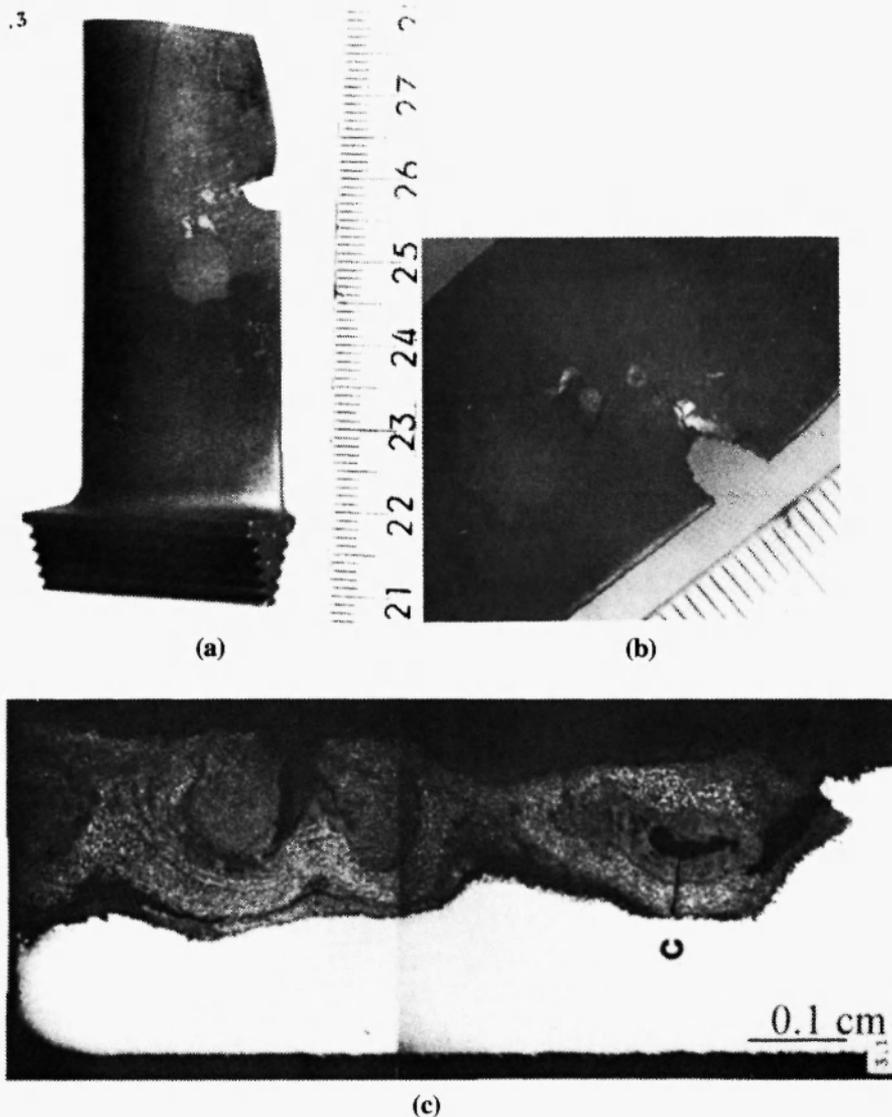
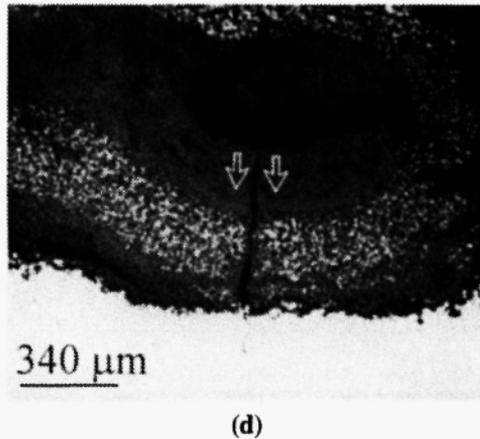
One of the case studies of hot corrosion is summarized here. A severely damaged turbine blade was inspected in the lab. Macroscopic inspection indicated the loss of a large piece of blade near the leading edge, at about 1.7 cm from the top of the blade (Fig. 15a). A long crack, about 4.6 mm in length, was found to propagate from this region into the material (Fig. 15b). The crack was then opened at the lab. Inspection of the fracture surface under an SEM revealed fatigue striations, propagating from the leading edge of the blade. Striation analysis indicated the occurrence of high-cycle low-stress fatigue. A transverse metallographic cross-section was prepared through the origin of the crack, perpendicular to the fracture surface, and inspected under an optical microscope. A relatively advanced hot corrosion attack was observed (Fig. 15c), with oxidation penetrating deeply into the blade (up to about 0.8 mm). This high penetration depth, combined with large blisters and eddies within the scale, indicate that the hot corrosion had already progressed to an advanced stage (termed stage 4. In addition, a secondary crack was found to propagate from the scale into the base material, in parallel to the

main fracture surface (Fig. 15d). A similar crack could ultimately propagate to catastrophic failure under fatigue mechanism. SEM/EDS analysis identified the blade material as cast IN 713C, known for its susceptibility to hot corrosion. Based on the aforementioned observations, it was concluded that the blade failed as a result of crack propagation under low stresses of

**Fig. 15:** (a) Macroscopic view of a turbine blade, indicating the loss of a large piece of material near the leading edge. (b) A crack propagating into the remainder material. (c) Optical micrograph indicating advanced hot corrosion attack. (d) A secondary crack propagating from the scale into the base material, in parallel to the main fracture surface /14/.

vibrations. The origin of the fatigue crack was a preliminary crack (or flaw), formed as a result of advanced hot corrosion attack. Thus, the recommendations of this investigation included replacement of all turbine blades and re-examination of all washing and monitoring operations.
