Available online at [www.sciencedirect.com](http://www.sciencedirect.com)

Engineering Failure Analysis 12 (2005) 337–347

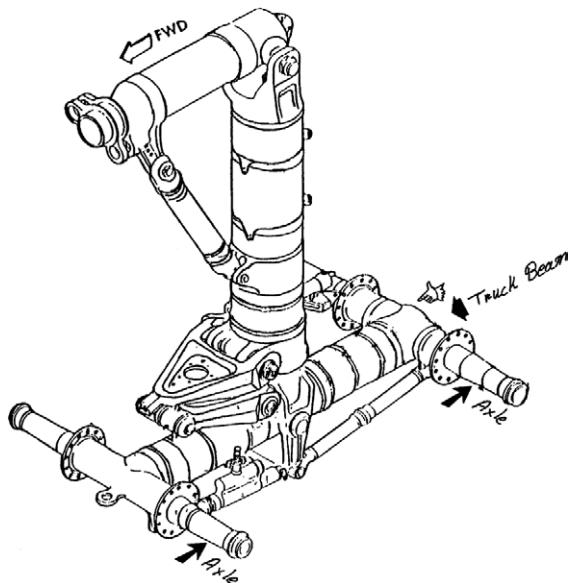
Fig. 1. Illustration of the main landing gear assembly on the subject aircraft. A finger marks the region of failure.

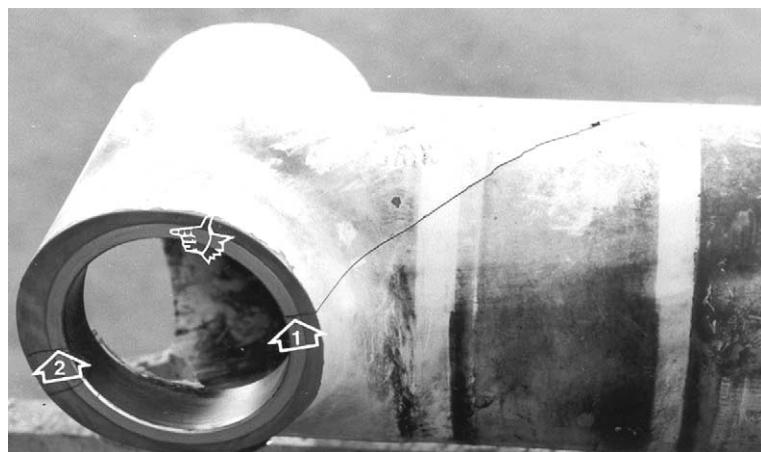
Fig. 2. Macroscopic view of the rear side of the R/H truck beam, revealing two crack origins (marked with arrows), one on each side of the bore.

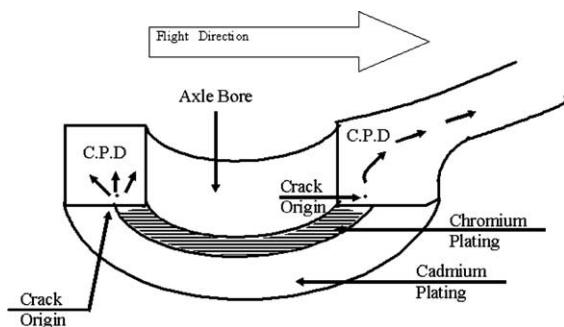
Fig. 3. Scheme of fracture. The chromium-plated zone, crack origins and fracture course are all marked.

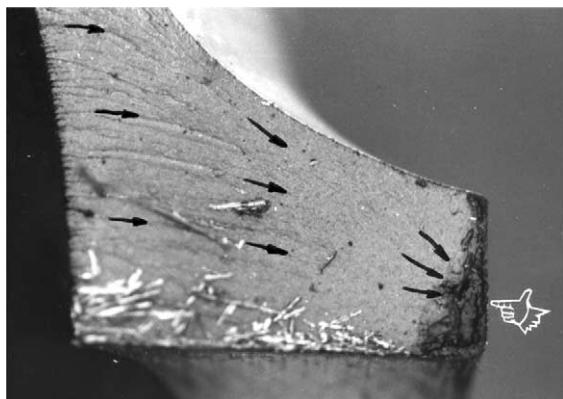
Fig. 4. Stereomicroscope image of the fracture surface around origin 1 from Fig. 2. A dark thumbnail-shaped beachmarks region near the wall is marked with finger.

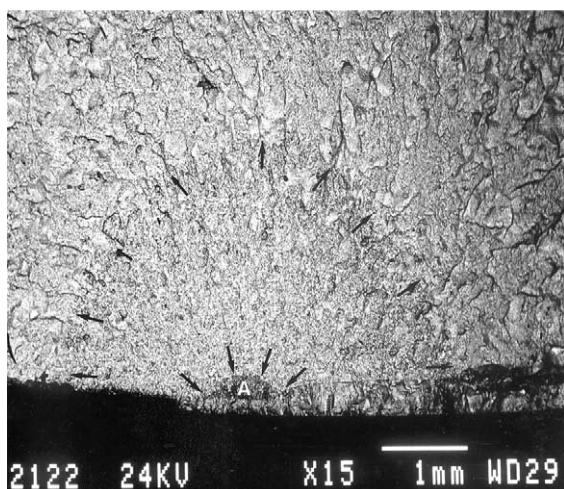
Fig. 5. SEM photomicrograph (back-scattered electrons image) showing origin 2 from Fig. 2 and its surroundings. Two thumbnail-shaped beachmarks zones are marked by arrows. The origin is located within the runout plateau where the chromium layer is thin.

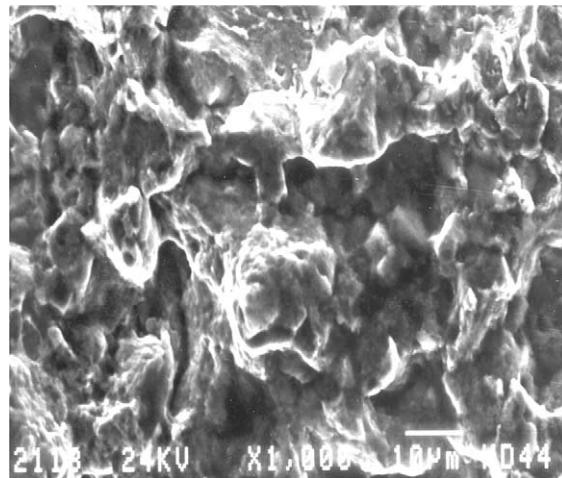
Fig. 6. SEM photomicrograph demonstrating corrosion features within the inner beachmarks zone around origin 1 from Fig. 2.

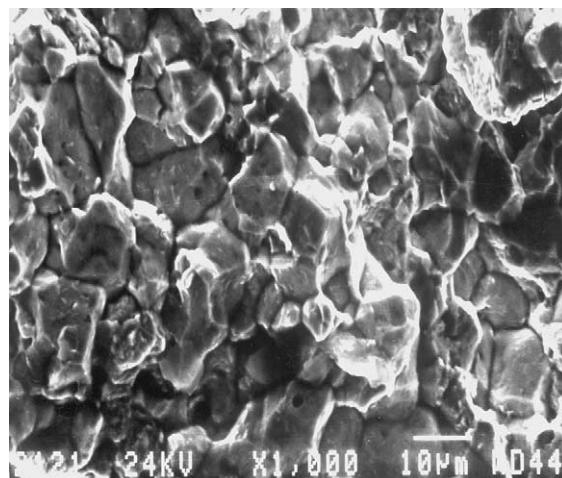
Fig. 7. SEM photomicrograph showing an intergranular fracture morphology within the outer beachmarks zone around origin 1 from Fig. 2. This morphology is typical, among other, to SCC.

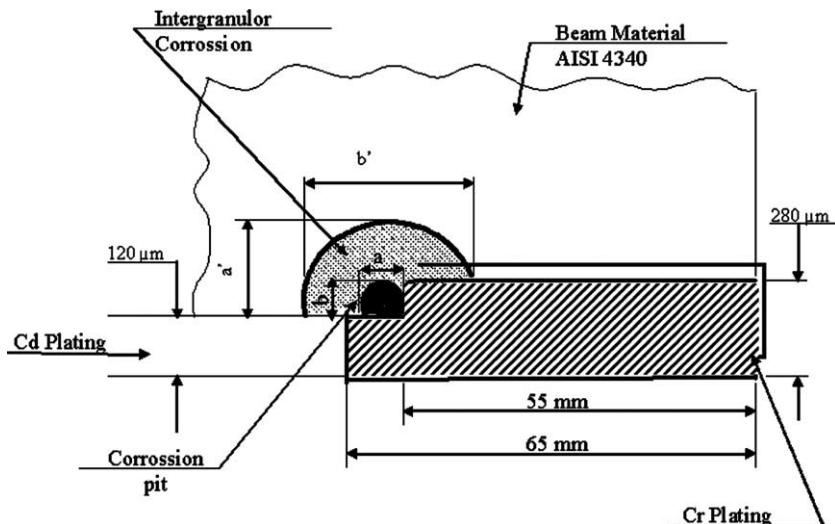
Fig. 8. Scheme of the fracture surface. The area coated with chromium, the corrosion-related pit, and the intergranular corrosion region are shown not in scale. Various dimensions are specified in Table 1.

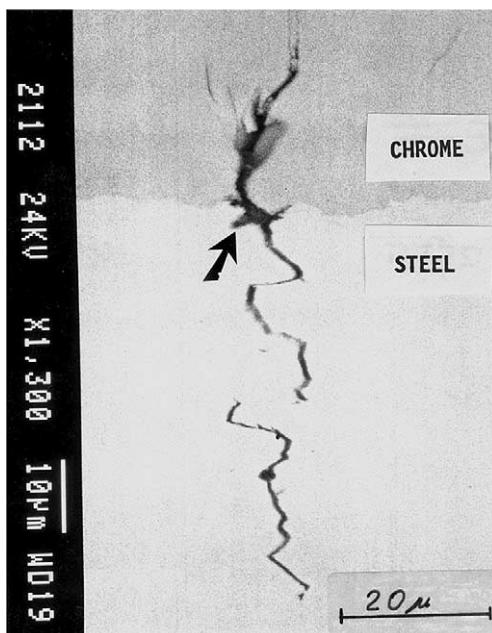
Fig. 9. Microscopic view of an area close to one of the crack origins. The metallographic cross-section was prepared perpendicular to the fracture surface. A secondary crack propagating through the chromium layer into the substrate, in parallel to the fracture surface, is evident. A corrosion pit is evident at the interface between the substrate and the coating.

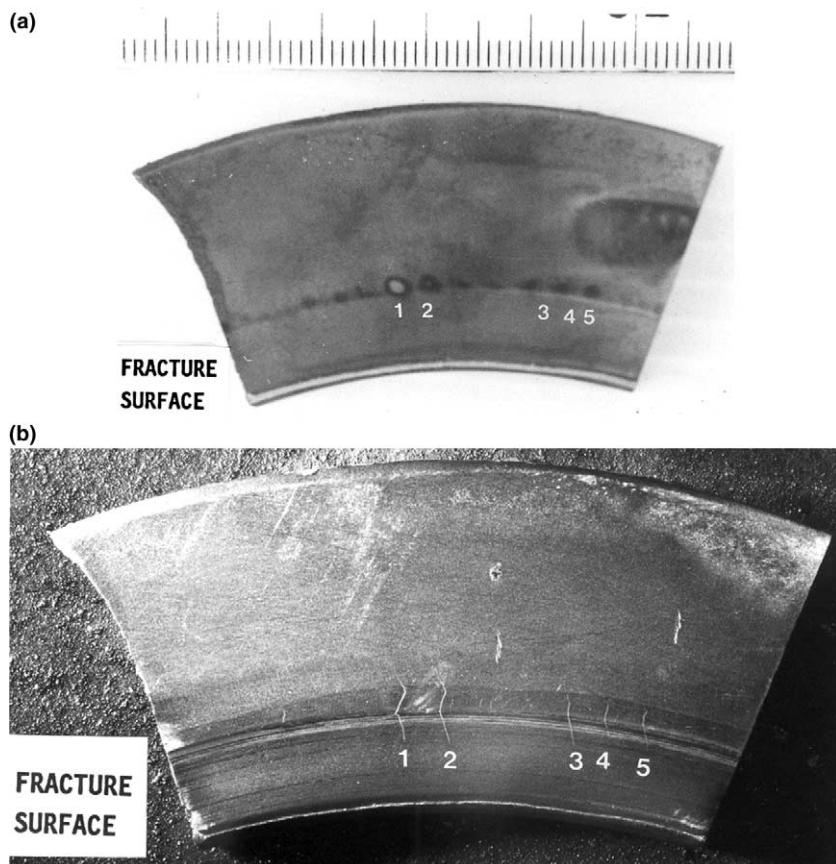
Fig. 10. View of the bearing surface of the R/H truck beam specimen: (a) areas of overtempered and untempered martensite after Nital etch. Magnification  $\sim 1.9\times$ ; (b) thermally induced cracks present in the heat-affected areas revealed by magnetic particle inspection. Magnification  $\sim 1.4\times$ .

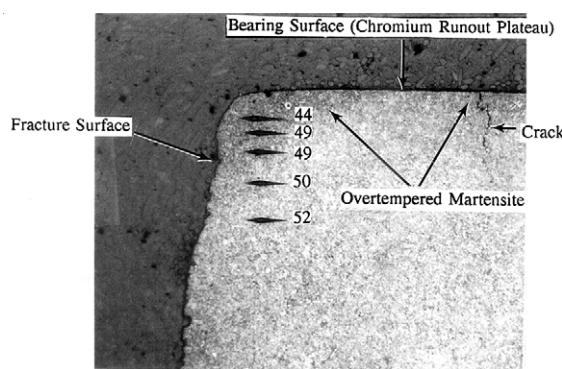
Fig. 11. Photomicrograph showing the overtempered martensitic microstructure (dark area) adjacent to the origin of the fracture surface from the L/H truck beam specimen. Microhardness Knoop measurements (values converted to HRC) were taken in this area and the surrounding normal tempered martensitic structure and are shown to the right of the indentations. Note the crack (arrow) emanating from the bearing surface in a similar overtempered martensitic area. Magnification  $\sim 100\times$ .
