Failure Analysis and Condition Monitoring of an Open-Loop Oil System Using Ferrography

Abstract Condition monitoring of dynamic systems based on oil analysis is well known for closed-loop systems. The motivation for this work stemmed from repeating failures of Wankel engines. Failure analysis identified contact fatigue as the failure mechanism, but could not identify the cause. Thus, the objective of the work was to develop a method for condition monitoring of open-loop oil systems. A variety of analytical techniques was evaluated, including direct-reading ferrography, analytical ferrography combined with computational image analysis, atomic emission spectroscopy, and scanning electron microscopy combined with energy dispersive X-ray spectroscopy. Procedures for collection and separation of oil samples were developed. Analytical ferrography was found most useful in condition monitoring. Six engines were detected in their early failure stage. Those engines were disassembled, and contact fatigue failures in the bearing needles were observed. The quantitative image analysis allowed for a fairly objective rating of the wear level. The method developed in this work has already been imp

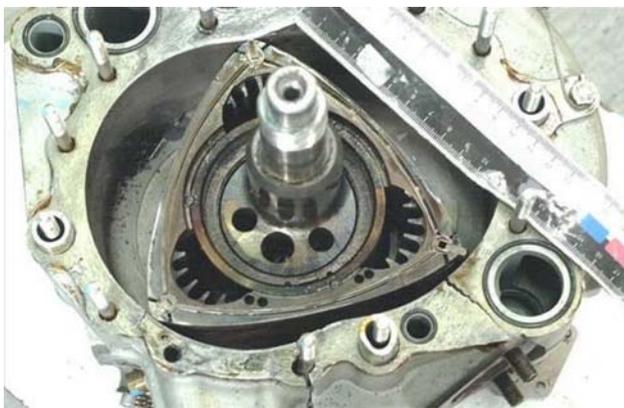
Fig. 1 A Wankel engine that failed

The motivation for this work stemmed from repeating failures of Wankel engines. During an engine operation, failure occurred and the engine ceased operating. Black oil was found at the air outlet and low compression values were measured. Similar events occurred in three other engines. It was hypothesized that oil analysis may aid in monitoring the condition of the engine, although it is an open-loop oil system. Thus, the objective of this work was to develop an analytical method for condition monitoring of open-loop systems. The Wankel engine served as the case study. A by-product of this work may be extension of the use of ferrography to new applications that have not been explored before.

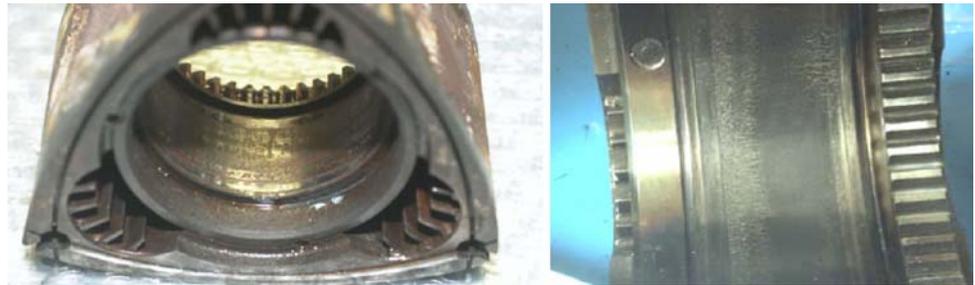
Fig. 7 Typical pitting on the internal circumference of the rotor

Visual inspection of the rotors from three failure events revealed clusters of pits adjacent to the drive side of the rotor bushing, radial cracks at identical distances along the circumference of the bushing, and excessive wear on the upper side of the rotor faces. The pits on the rotor surfaces (Fig. 7) seemed visually similar to those observed on the needles. Thus, it was concluded that the rotors failed in the same contact fatigue mechanism. Geometrical investigation showed an enlargement of the bushing inner diameter. Measuring the inner diameter along the bushing axis, from the drive side to the non-drive side, it became evident that the maximum enlargement was at the drive side.

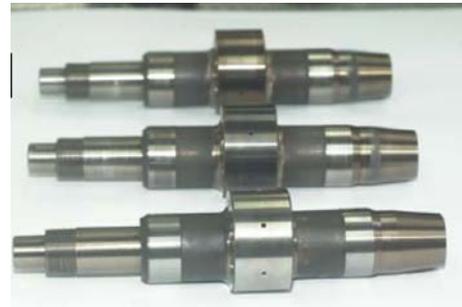
Fig. 9 The shaft with eccentric element from the first failure event (*middle*), a used item (*top*) and a new item (*bottom*)

The shaft has an eccentric element, on which the rotor bearing rotates. The outer diameter of the eccentric element is the surface loaded by the engine operation through the rotor and the needles bearing. Visual inspection of the eccentric elements in the shaft revealed evidence of exposure to high temperature (upper and middle shafts in Fig. 9) and material removal from the surface (Fig. 10). Geometrical measurements showed no change in the outer diameter of the eccentric element compared to the upper and lower limits specified in the drawing.

The chemical composition and micro-hardness of the shaft material matched the drawing requirements. Yet, it should be noted that some time before failures started to occur, the manufacturer changed the design and raised the hardness requirement from 60 R_C to 66–67 R_C . The rationale was to reduce distortions. However, Zaretsky et al. [40] found that the maximum fatigue life and load capacity of rolling-element bearings made of SAE 52100 steel was achieved when the rolling elements were 1–2 R_C
